CHEROKEE NATION
Environmental Programs

Asbestos Sampling Report

PARTICIPANT: MCCARTER, DOUGLAS

Site Name: Douglas McCarter
Address: 17565 W. Robin Drive, Tahlequah, OK 74464
Phone: (918) 457-9362
Lat/Long: 35.97584 N, 94.98233 W

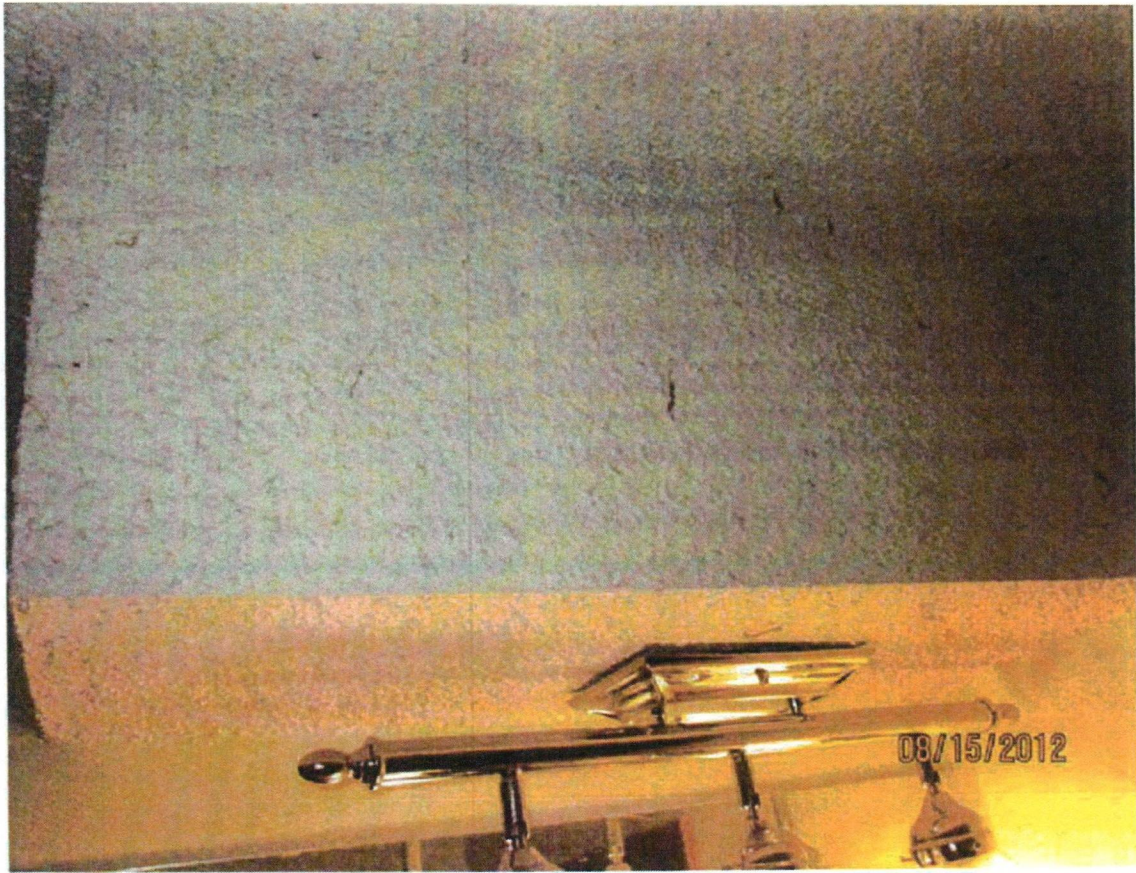
Sample #	Material Description	Locations	Friability (Friable, NF Cat I NF Cat II)	Condition	Sample Results (% Asbestos)
01-04	Wall/Ceiling Texture	Bathroom	Friable	Good	4%
01-05	Wall/Ceiling Texture	Bathroom	Friable	Good	4%
01-06	Wall/Ceiling Texture	Bathroom	Friable	Good	4%
01-07	Joint Compound	Living Room Wall	NF Cat II	Good	2%

Bathroom Wall/Ceiling Texture (4%) Chrysotile Asbestos

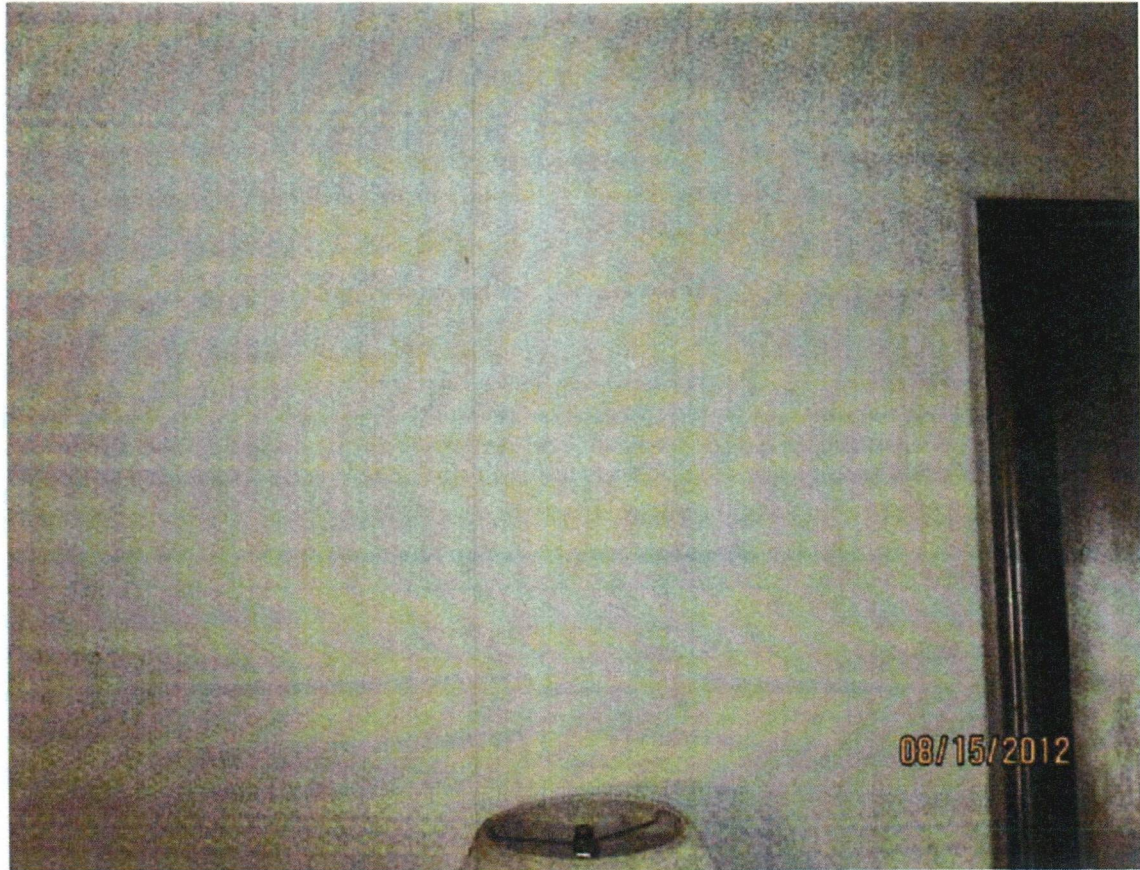
Living Room Joint Compound (2%) Chrysotile Asbestos
