**CHEROKEE CASINO
ROLAND**
Roland, Oklahoma

**WALL
SECTION &
DETAILS**

A307

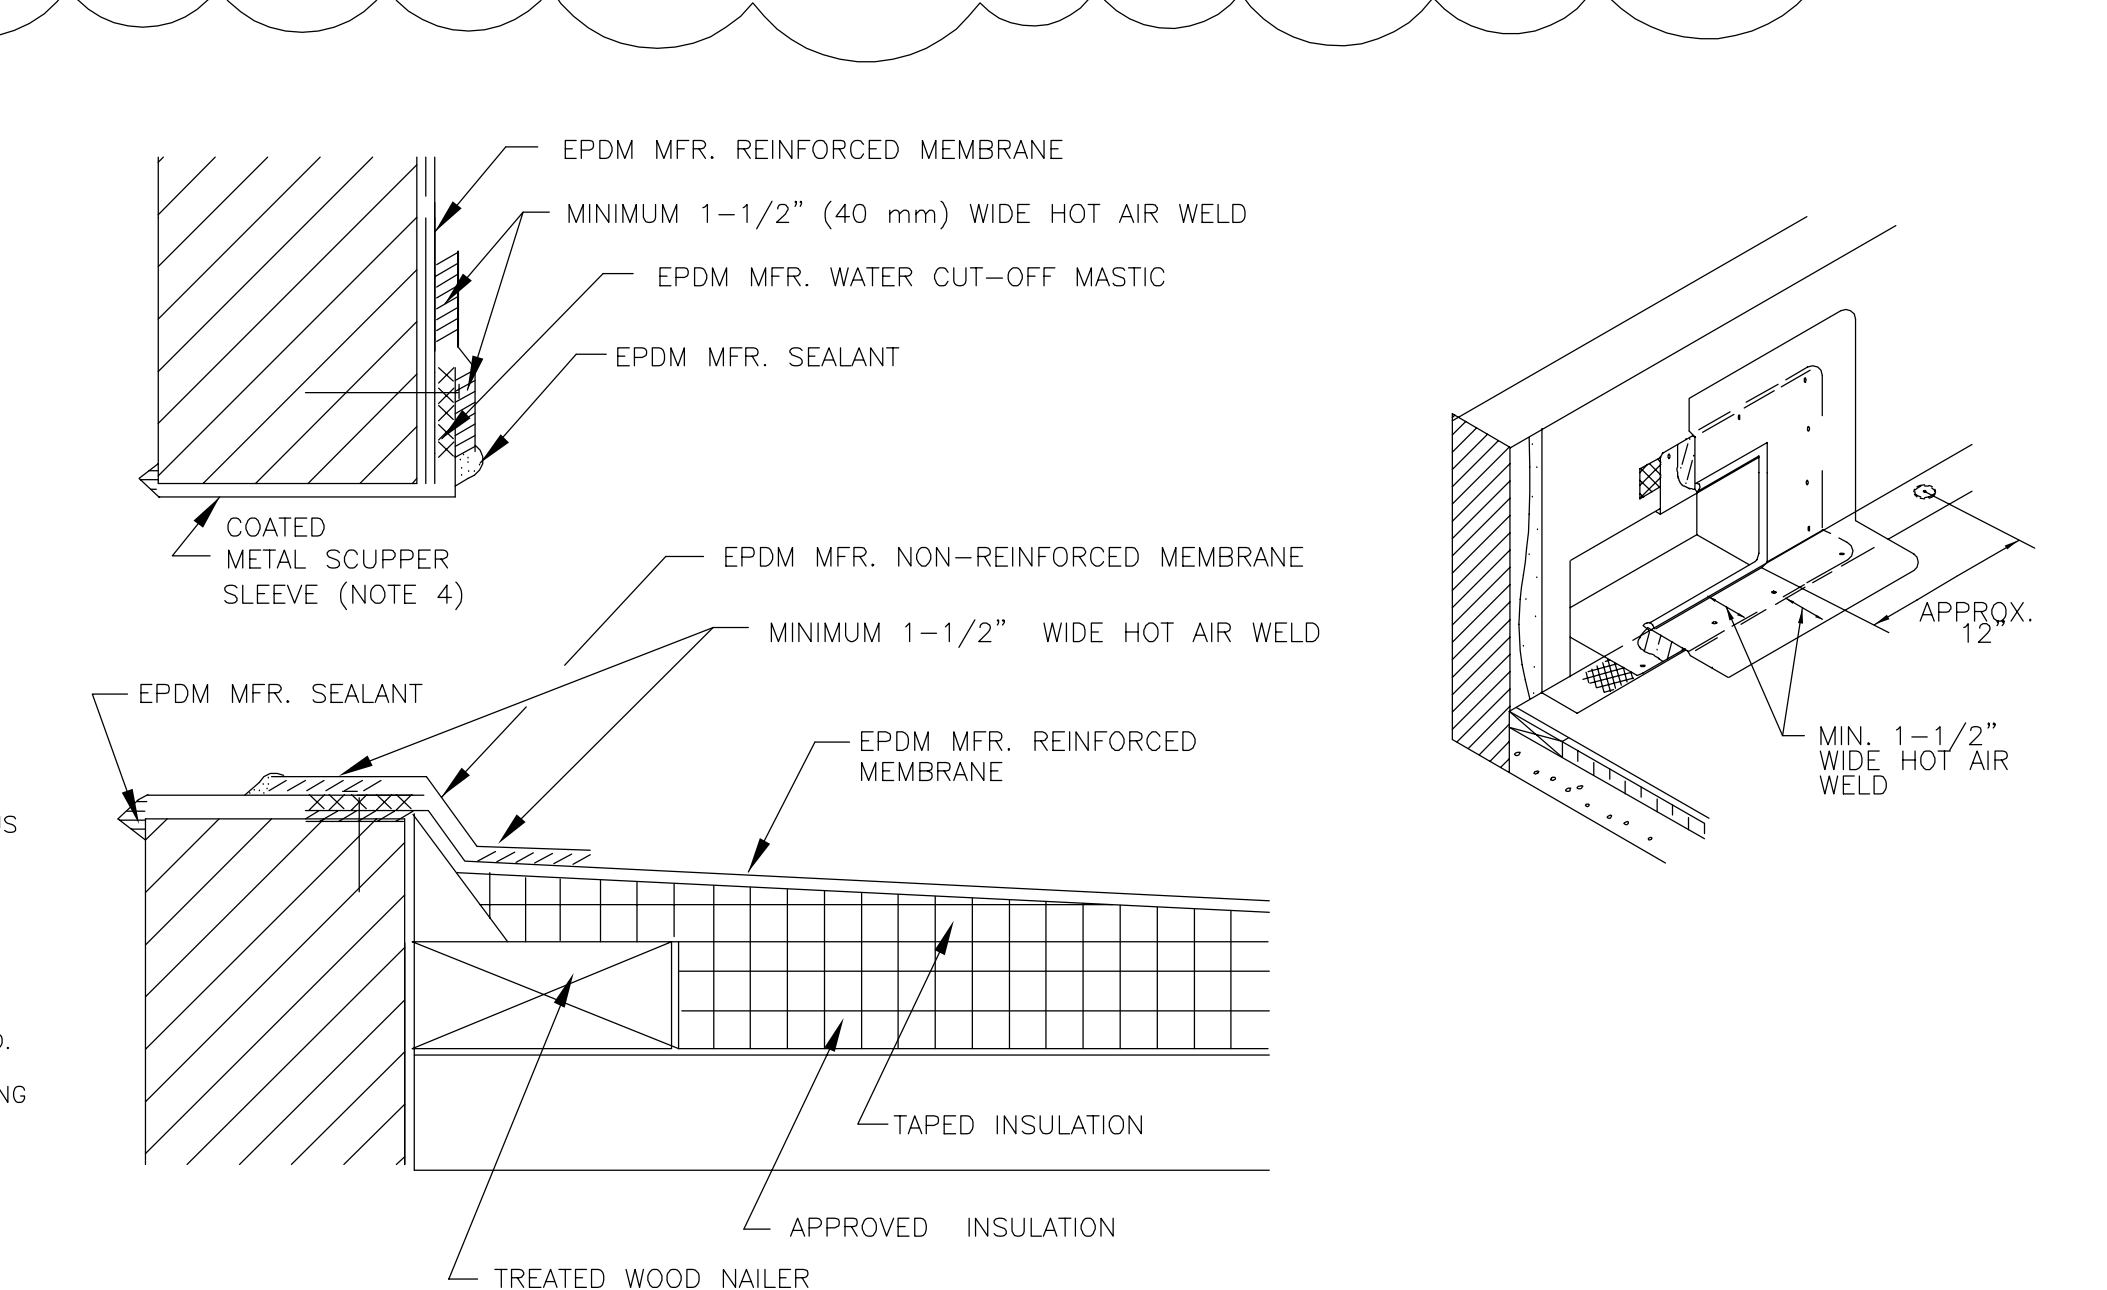
- OVERFLOW SCUPPER NOTES:**
- TREATED WOOD NAILER MUST EXTEND PAST TOTAL WIDTH OF DECK FLANGE.
 - INSTALL WALL FLASHING PRIOR TO SCUPPER INSTALLATION.
 - DISCONTINUE FASTENING PLATES AT SCUPPER OPENING AS SHOWN.
 - METAL SCUPPER BOX MUST HAVE CONTINUOUS SIDES: METAL FLANGE MUST BE CONTINUOUS WITH ROUNDED CORNERS.
 - WATER CUT-OFF MASTIC UNDER SCUPPER FLANGE MUST BE UNDER CONSTANT COMPRESSION.
 - MINIMUM 2" (5 cm) SPLICE FROM NAIL HEAD.
 - EPDM MFR. SEALANT IS REQUIRED AT FLASHING EDGE ON SCUPPER EDGE.
